# UNDERWATER BRIDGE INSPECTION REPORT

STRUCTURE NO. 23513

ROOT RIVER

MINNESOTA DEPARTMENT OF TRANSPORTATION  
UNDERWATER BRIDGE INSPECTION

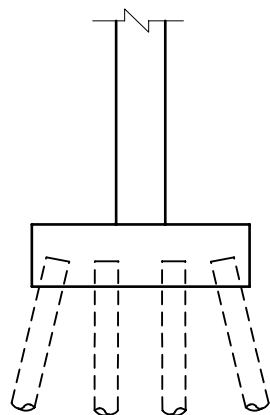
**TYPICAL END VIEW OF PIERS**

- 4 A scour depression, 2 foot deep and 6 feet in radius, was observed at the upstream nose of the pier.
- 5 The top of the footing was exposed around the entire pier with up to 3.2 feet of vertical footing exposure at the upstream end of the pier with no undermining observed.

- 6 A scour depression, 1 foot deep and 3 feet in radius, was observed at the upstream nose of the pier.
- 7 A scour depression, 6 inches deep and 2 feet in radius, was observed at the upstream nose of the pier.

- 8 An 18 inch diameter log was observed across the upstream nose of the pier.
- 9 A light accumulation of branchy timber debris was observed along the east face and downstream nose of Pier 3.
